# GENERATOR EXHAUST SELECTION FOR MISSION-CRITICAL FACILITIES

**A comparative analysis of traditional sealant-based pressure stack and the graphite-gasket system, prepared for specifying engineers and mechanical contractors serving data centers and other mission-critical facilities.**

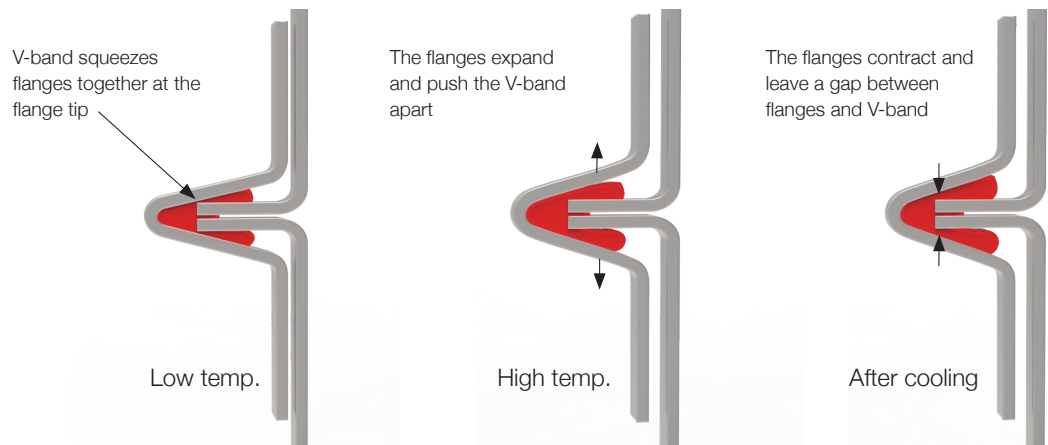
These images show the movement of the flanges within a **V-Band**.

A V-band clamp seats against the flange edge and acts as a wedge. As the joint heats, the flange expands and pushes the V-channel open; on cooling, the channel does not fully spring back. Testing has shown the channel can open permanently by roughly 0.04–0.1 inch (1–2 mm) after repeated heat cycles — loosening the mechanical clamp and compromising the pressure seal it was designed to hold. A generator that starts and stops daily, or several times a day, puts far more thermal cycles through a joint over its service life than the one-time or limited-cycle assumptions built into the listing tests.

Where a V-band wedges against the flange edge and can deform under cyclic heating, the U-band compresses the gasket along the sides of the flange. Thermal expansion of the inner liner is absorbed inside the U-channel itself, without deforming the band, the flange, or the gasket, and without transmitting additional stress back into the joint. The result is a joint that behaves consistently on cycle 1 and on cycle 10,000.

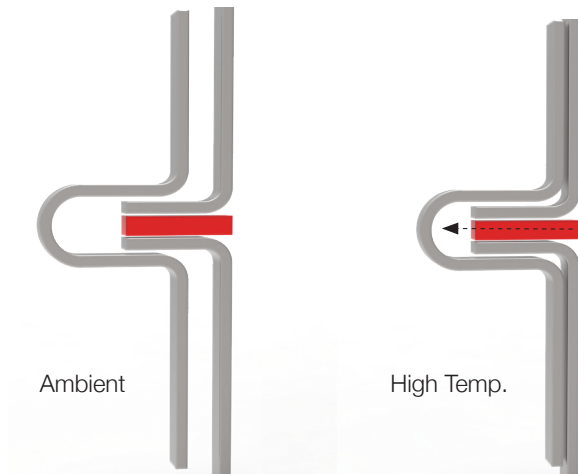
— and these show the movement of the flanges within a **U-Band**.

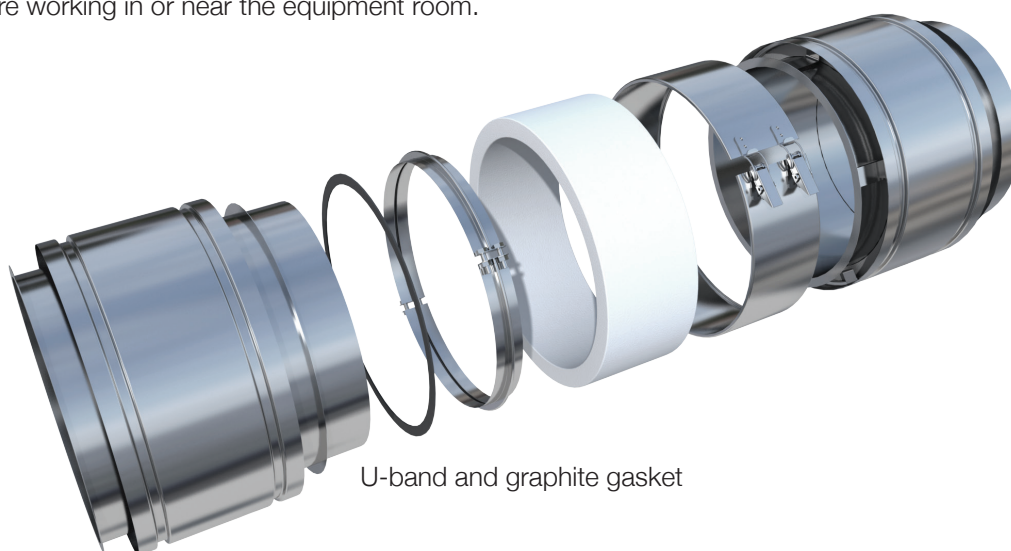
U-band and graphite gasket

New technology from ENERVEX replaces the sealant-and-V-band joint with a bonded graphite gasket, reinforced with a thin stainless-steel foil layer, compressed by a purpose-built U-band clamp. The gasket is factory-bonded to the male flange end of each section, so there is no field-applied sealant, no cleaning of flanges or grooves, and no cure time before the joint can be placed in service.

Graphite brings a combination of properties that sealants cannot match in a sealed, high-temperature, condensate-exposed joint: it is relatively soft and conformable, dimensionally stable over long service life, resistant to thermal shock, largely impermeable to gases and liquids, chemically inert, and unaffected by acidic condensate. A 0.08-inch graphite/foil gasket is rated across a temperature range of roughly  $-328^{\circ}\text{F}$  to  $+1,832^{\circ}\text{F}$  and positive pressures up to 2,000 psi — far beyond what a chimney application demands, which is the point: the joint is no longer the limiting component.
